SENNEBEC POND DAM
ME 00248

PHASE I INSPECTION REPORT
NATIONAL DAM INSPECTION PROGRAM

APRIL 1981

Identification No.: ME 00248
Name of Dam: Sennebec Pond
Town: Union
County and State: Knox, Maine
Stream: St. George River
Date of Site Visit: 7 November 1980

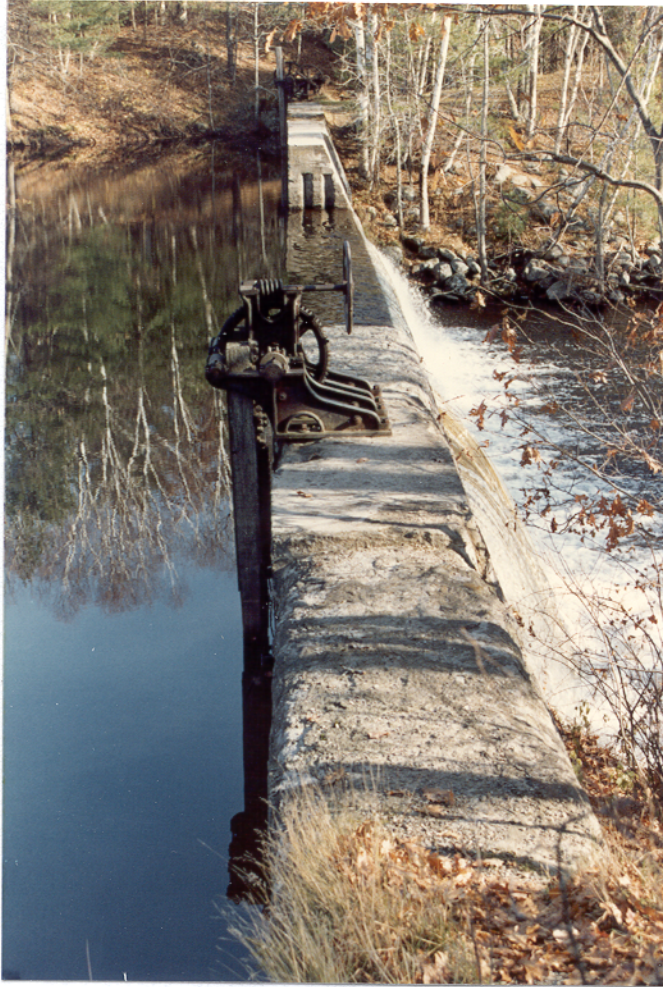
The horizontal and vertical alignments of the dam, Photo Nos. 2 and 3, were satisfactory and did not show evidence of significant lateral movement or settlement. The spillway was obscured from view by flowing water during the site examination. However, based upon those portions of the spillway that could be seen and the uniformity of flow over the weir, this part of the structure appeared to be in good condition. There was a depression 4-in. deep, 12-ft. long and 1.4-ft. wide located at the right end of the spillway, towards the downstream side.

2. Vertical alignment of dam from right abutment

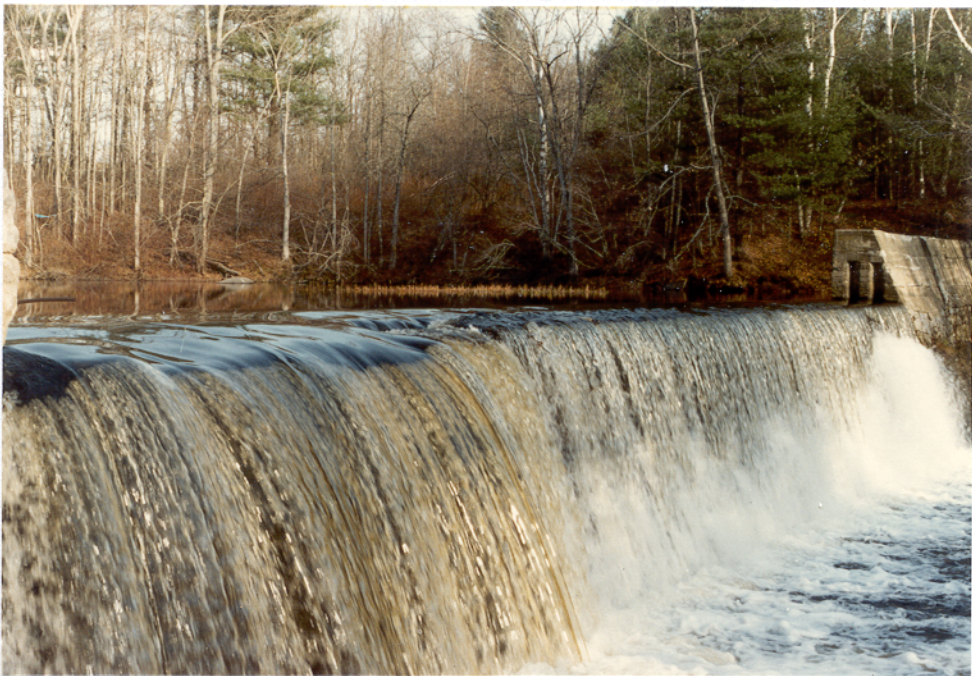
3. Horizontal alignment of spillway crest, downstream

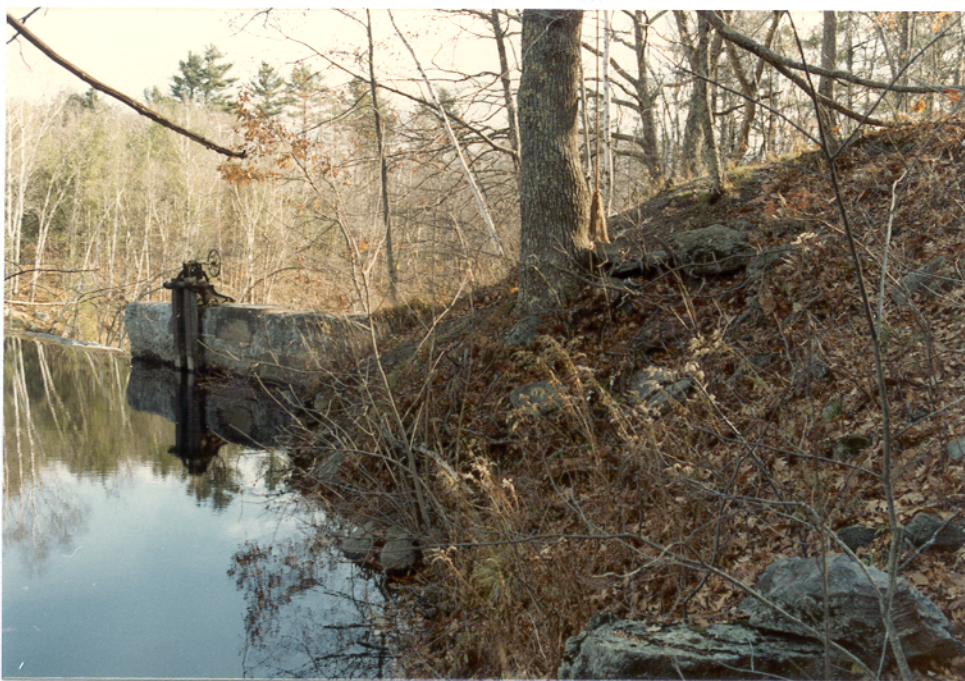
Both the right and left ends of the dam abut steeply sloping rock surfaces covered with boulders and soil. Soil on the slopes supports a thick covering of forest vegetation, Photo Nos. 4 and 8. Rock outcrops were exposed both upstream and downstream of the right abutment. However, based upon available data the dam may be founded on either "hardpan" or "ledge", (see Appendix page B-11), or partially on both.

4. Right abutment, upstream

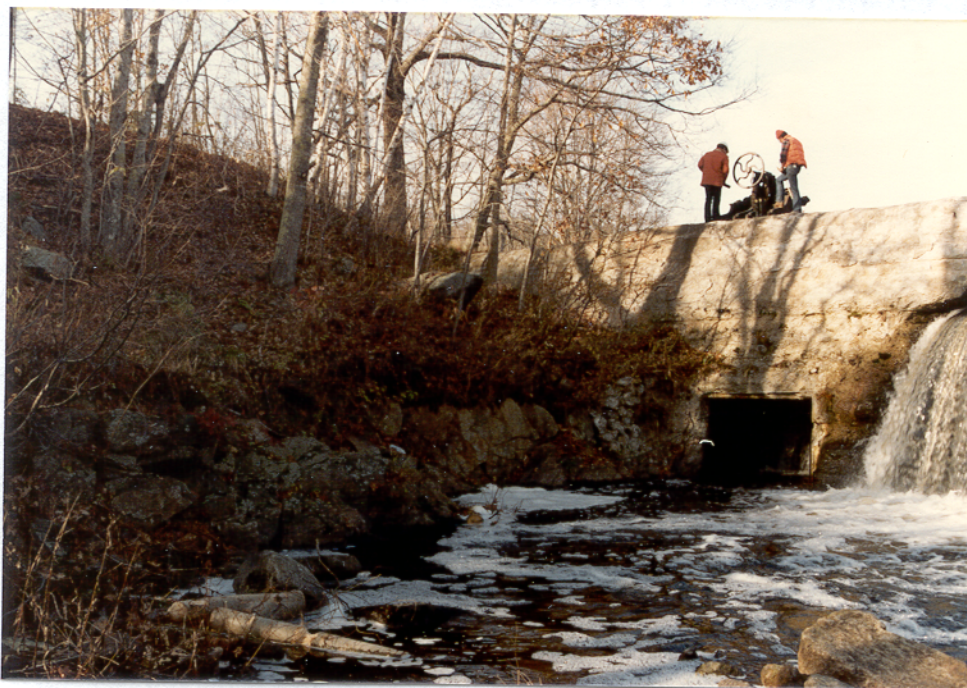
The concrete of the sections to the right and left of the spillway was scaled and spalled. Some concrete was eroded at the right spillway training wall, Photo No. 5, and along the upstream face of the left section of the dam in the vicinity of the spillway waterline, Photo No. 6.

c. Appurtenant Structures. The outlet works discharges directly into the downstream channel, Photo No. 5. Examination of the outlet works chamber revealed leakage through the deteriorated wood gate. The owner's representative, present during part of the site examination, reported that the upstream side of the outlet works slide gate had been sandbagged during a period of low flow to reduce leakage and help maintain the pond near the recreational pool level. The concrete surface of the gate chamber walls was spalled and eroded; however, no reinforcing was visible. The outlet works gate lift mechanism was operable but, due to the sandbags placed against the upstream side of the gate, it could not be raised. From the conditions both reported and observed, it appeared that the outlet works were readily serviceable.

5. Right abutment and outlet works, downstream

1. Repair the spalled and eroded areas of the concrete portions of the dam including the depression located at the right end of the spillway weir.
2. Make repairs as necessary to restore the outlet works gate to serviceable condition. Also, the owner should consider repairing the three canal intake gates to serviceable condition or sealing the openings to prevent leakage.

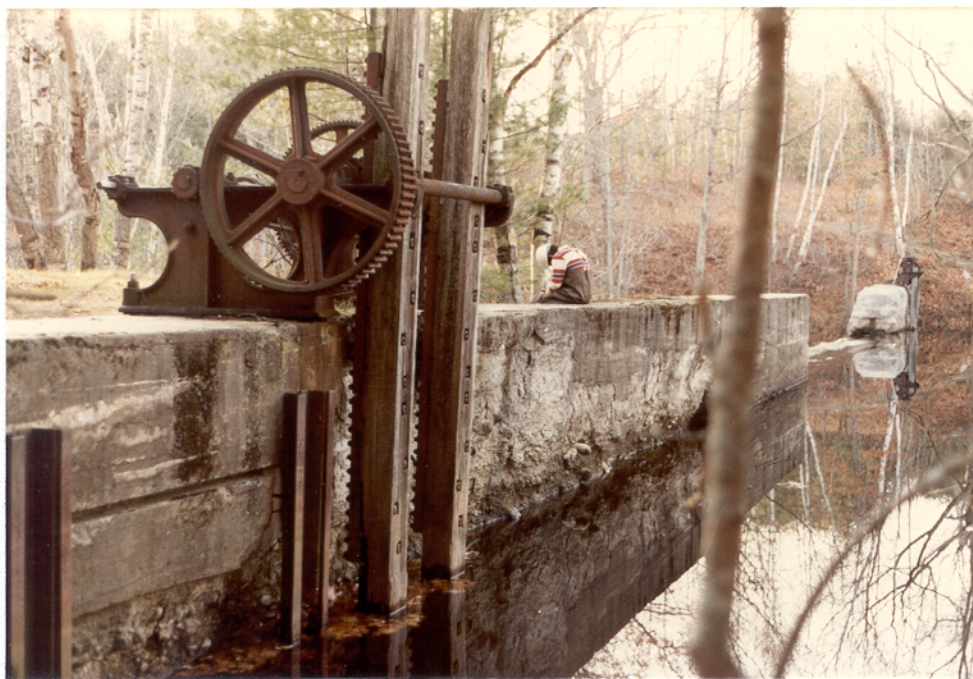
The three slide gates at the left side of the dam were submerged, thus precluding direct examination. Only one of the three gate lift mechanisms was present, Photo No. 6. It was not operable and did not appear to be in readily serviceable condition. It is not known when the two other gate lift mechanisms were removed. The existence of a tailwater pool in the canal indicated leakage through one or more of the intake gates. It was reported that the three intake gates had also been sandbagged, at the upstream side, to reduce leakage. The concrete training wall at the right side of the canal was in fair condition, Photo No. 7. The visible lower portion of the wall was considerably spalled and eroded, however, alignment of the wall did not indicate major lateral movement or settlement.

6. Left side of dam, upstream

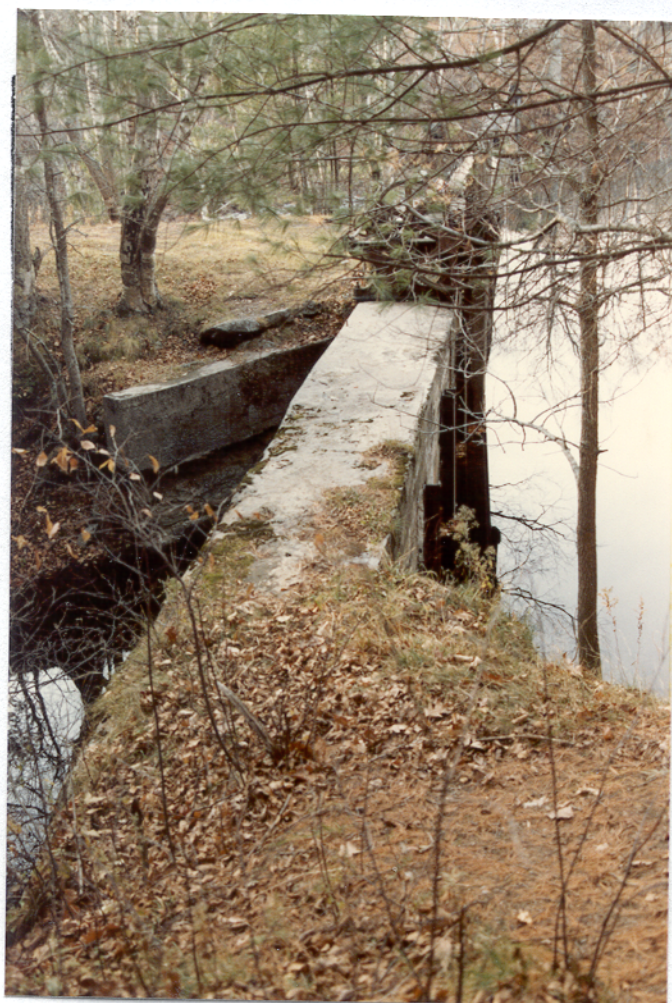
7. Alignment of dam
at left abutment

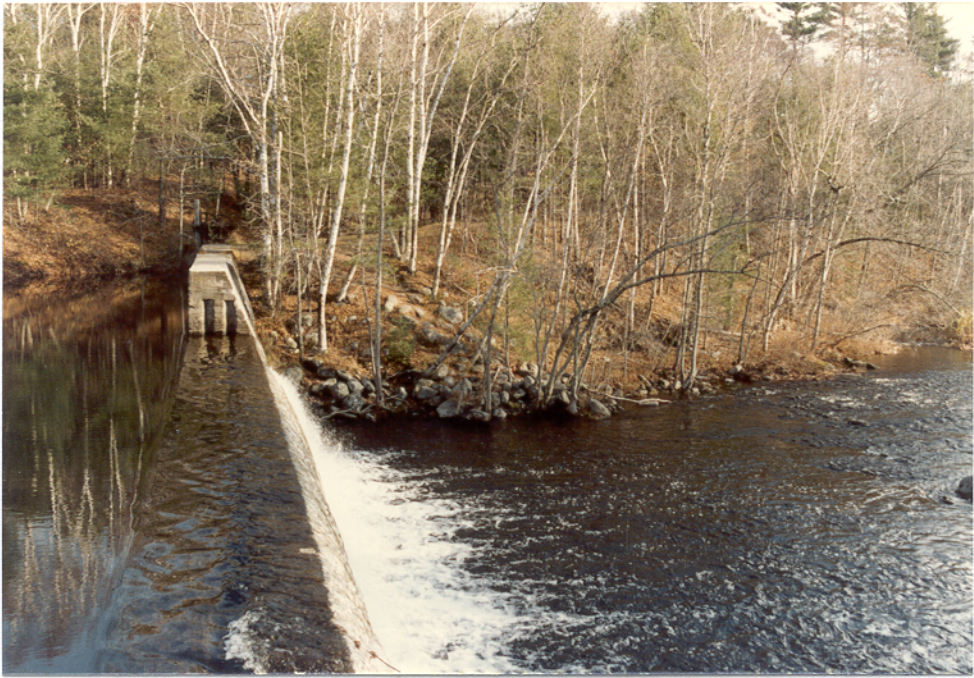
8. Ridge that separates river channel from canal, located at left side of dam, and left abutment

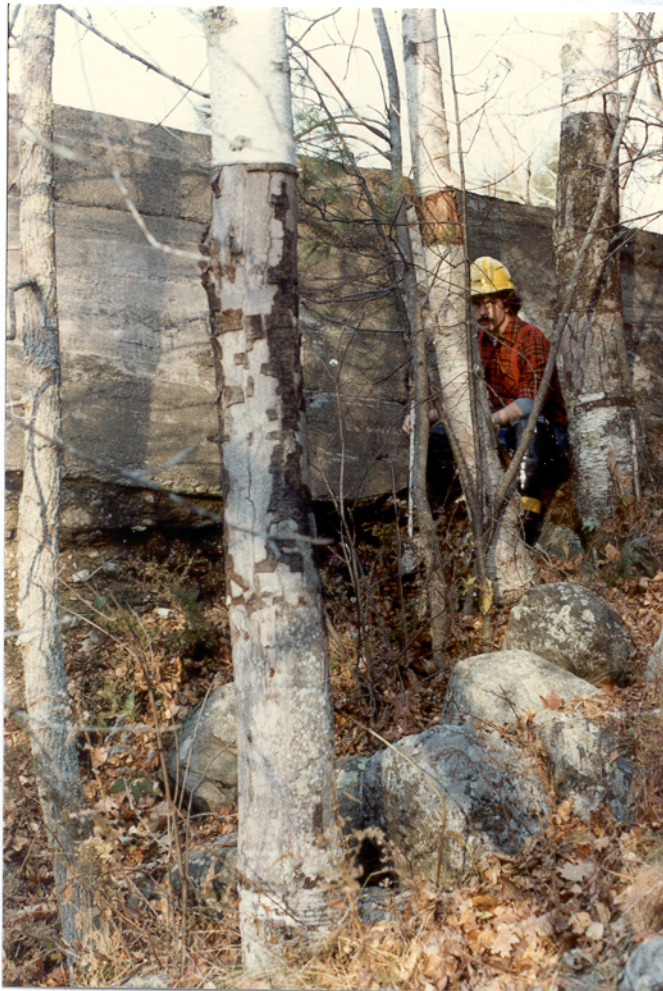
spillway training wall and coincident with the spillway crest elevation. The water was clear and the quantity of flow was too small to be estimated. There were no associated rust stains in the seepage area but the condition appeared to be long standing. The right and left portions of the dam were in generally satisfactory condition and did not appear to be structurally unstable.

9. Location of seepage through concrete at right side of ridge, down-stream

3. Establish a program for monitoring the seepage at the downstream face of dam to the left of the spillway. While the seepage observed did not appear significant, repairs may be necessary if the condition worsens.

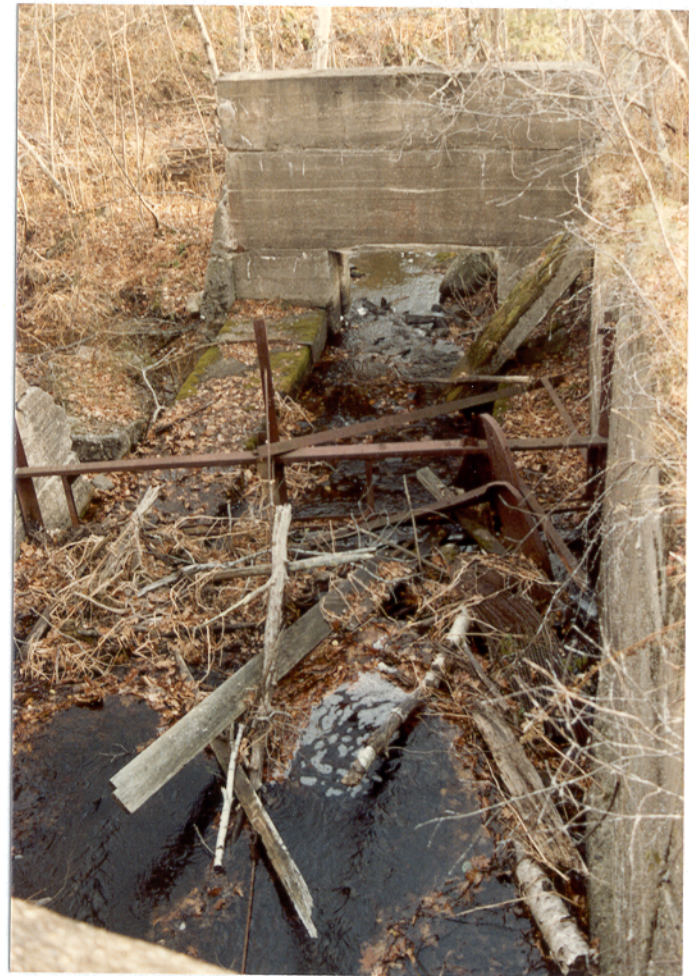
11. Concrete forebay at abandoned generating station, 700 ft. downstream from dam

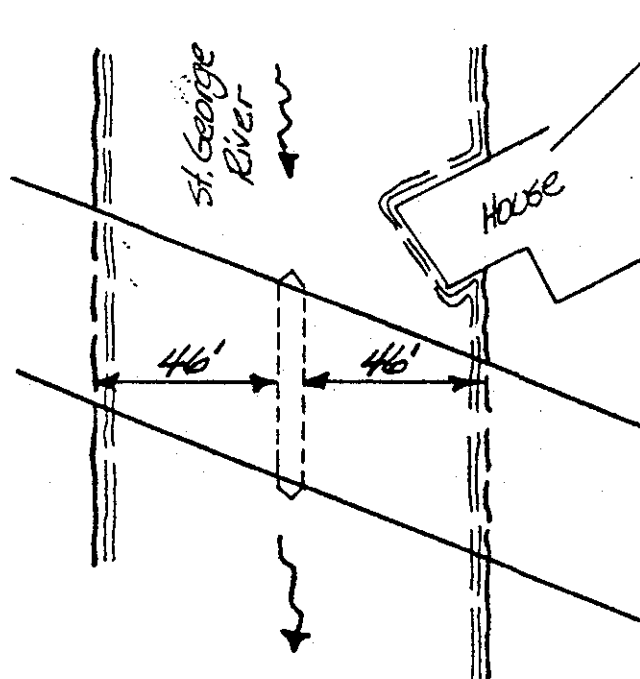
There is an existing house immediately u/s of this bridge which extends out about 25 ft. into the channel as indicated by the sketch below:

The basement of this structure is founded on the stream bed with the first floor sill elev. about 2 to 3 ft. below the top of Road.

Failure of the Sennebec Pond Dam would nearly overtop the road and impact on this structure, with the resulting potential for the loss of a few lives.
